**Flood Control Project Maintenance  
Levee Inspections**

## Maintenance Issue Types Only, Levee Inspection Report By Mile - Fall 2018

### Plumas County

Waterway	Bank	Unit Miles	Inspection Start/End	Inspector
Unit No. 01 North Fork Feather River	Left	1.89	09/19/2018 09/19/2018	Bob Duffey

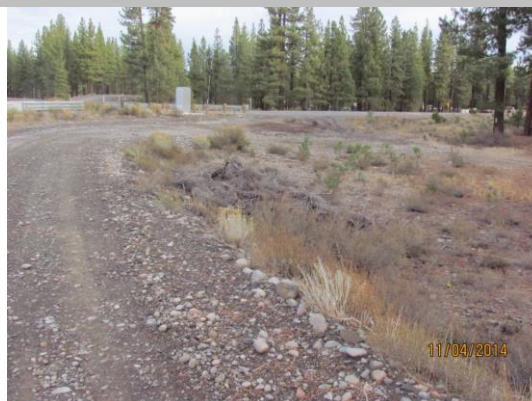
Photo 1 of 1 : FA\_2018\_NA0015\_337\_4\_20180905\_00001.jpg

LM Start	0.68	Rating **	M	Issue No.	4
LM End	0.68	Issue Type +	Ma	Location *	LS
Category	Earthen Levee			GPS Latitude/Longitude	
				Start	End
Item	Encroachments			40.281480 °	40.281480 °
				-121.250928 °	-121.250928 °
DWR ID	DWR_NA0015_01_s_2013_4				
Comment Code					
PR : Prunings					
Inspector Comment

View of the prunings along the landside slope.

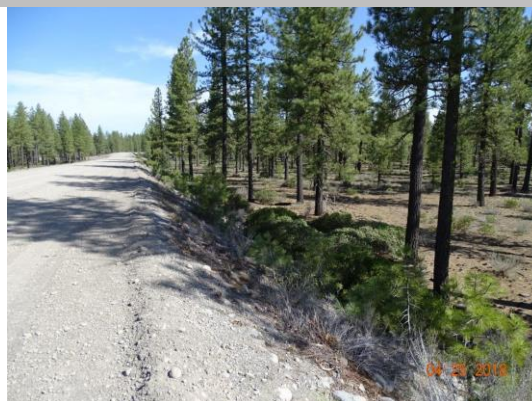
Photo 1 of 1 : FA\_2018\_NA0015\_337\_18\_20180905\_00009.jpg

View of the small pine trees and vegetation along the landside slope.

LM Start	0.79	Rating **	M	Issue No.	18
LM End	1.88	Issue Type +	Ma	Location *	LS
Category	Earthen Levee			GPS Latitude/Longitude	
				Start	End
Item	Vegetation			40.282962 °	40.297068 °
				-121.251307 °	-121.257120 °
DWR ID	DWR_NA0015_01_s_2018_18				
Comment Code					
V2 : Remove the wild growth other than native grasses from the levee slopes.					
Inspector Comment					
Remove the small pine trees and vegetation from the landside slope.

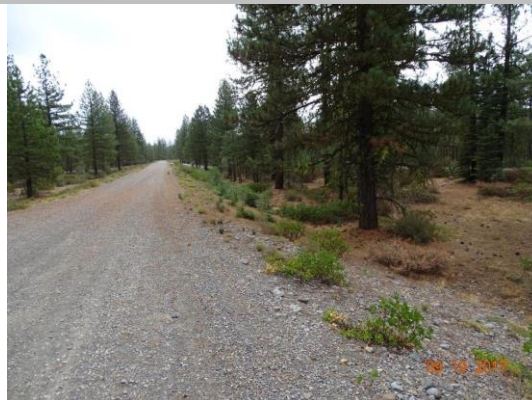
Photo 1 of 1 : FA\_2018\_NA0015\_338\_2\_20180905\_00001.jpg

View of the small pine trees and vegetation along the landside slope.

LM Start	0.00	Rating **	M	Issue No.	2
LM End	0.71	Issue Type +	Ma	Location *	LS
Category	Earthen Levee			GPS Latitude/Longitude	
				Start	End
Item	Vegetation			40.286462 °	40.279948 °
				-121.260082 °	-121.252118 °
DWR ID	DWR_NA0015_02_f_2017_2				
Comment Code					
V2 : Remove the wild growth other than native grasses from the levee slopes.					
Inspector Comment					
Remove the small pine trees and vegetation from the landside slope.

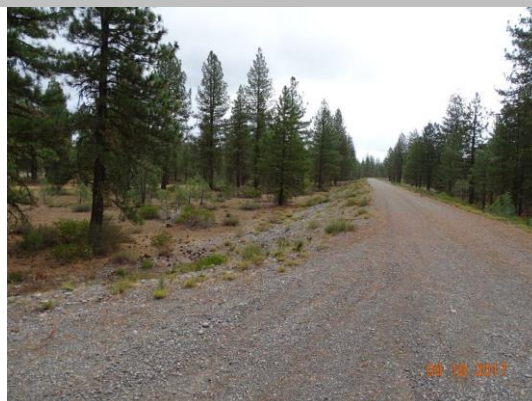
Photo 1 of 1 : FA\_2018\_NA0015\_338\_3\_20180905\_00002.jpg

View other small pine trees and vegetation along the waterside slope.

LM Start	0.00	Rating **	M	Issue No.	3
LM End	0.71	Issue Type +	Ma	Location *	WS
Category	Earthen Levee			GPS Latitude/Longitude	
				Start	End
Item	Vegetation			40.286462 °	40.279948 °
				-121.260082 °	-121.252118 °
DWR ID	DWR_NA0015_02_f_2017_3				
Comment Code					
V2 : Remove the wild growth other than native grasses from the levee slopes.					
Inspector Comment					
Remove the small pine trees and vegetation from the waterside slope.

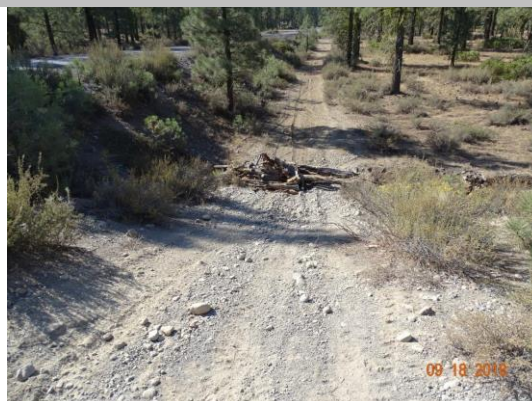
Photo 1 of 1 : FA\_2018\_NA0015\_338\_4\_20181001\_00013.jpg

LM Start	0.55	Rating **	M	Issue No.	4
LM End	0.55	Issue Type +	Ma	Location *	LS
Category	Earthen Levee			GPS Latitude/Longitude	
				Start	End
Item	Slope Stability			40.281950°	121.253710°
				40.281950°	121.253710°
DWR ID	DWR_NA0015_02_s_2012_4				
Comment Code					
S3 : Repair the levee slope damaged by vehicle traffic and prevent access where possible.					
Inspector Comment					
The vehicle erosion was repaired along the landside slope.

View of the repaired vehicle erosion along the landside slope.

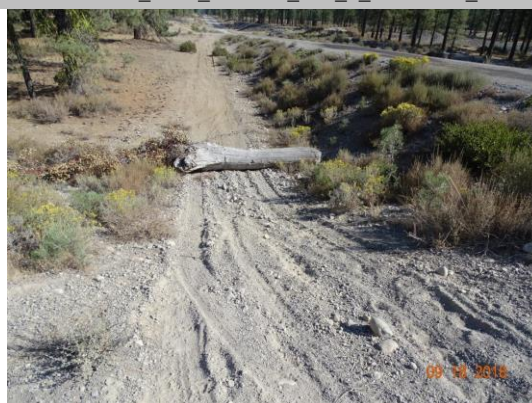
Photo 1 of 1 : FA\_2018\_NA0015\_338\_5\_20181001\_00012.jpg

View of the vehicle erosion along the waterside slope.

LM Start	0.55	Rating **	M	Issue No.	5
LM End	0.55	Issue Type +	Ma	Location *	WS
Category	Earthen Levee			GPS Latitude/Longitude	
				Start	End
Item	Slope Stability			40.281950 °	121.253710 °
				40.281950 °	121.253710 °
DWR ID	DWR_NA0015_02_s_2012_5				
Comment Code					
S3 : Repair the levee slope damaged by vehicle traffic and prevent access where possible.					
Inspector Comment					
Repair the vehicle erosion along the waterside slope.

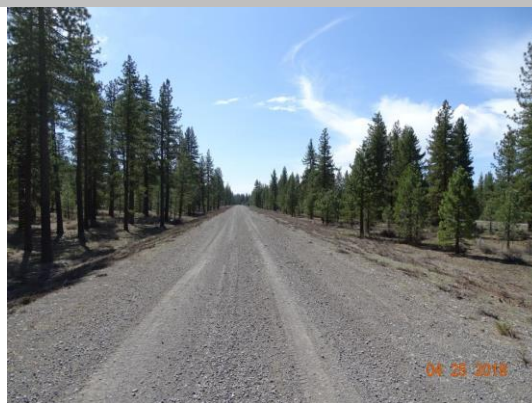
Photo 1 of 1 : FA\_2018\_NA0015\_338\_7\_20180905\_00007.jpg

LM Start	0.71	Rating **	A	Issue No.	7
LM End	1.36	Issue Type +	Ma	Location *	LS
Category	Earthen Levee			GPS Latitude/Longitude	
				Start	End
Item	Vegetation			40.279948 °	40.271748 °
				-121.252118 °	-121.246737 °
DWR ID	DWR_NA0015_02_s_2018_7				
Comment Code					
V2 : Remove the wild growth other than native grasses from the levee slopes.					
Inspector Comment					
Small pine trees were removed from the landside slope.

View of the removed small pine trees from the landside slope.
